HAZARDOUS MATERIALS SURVEY AND 2023 REASSESSMENT 850 PETER MORAND CRESCENT, OTTAWA, ON

Project No.: Z2021101HZ / CCC-230252-00

University of Ottawa

December 06, 2023

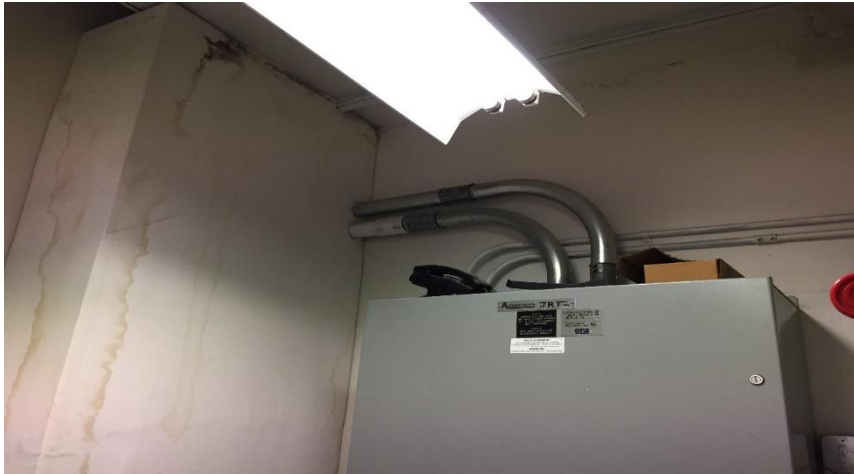
A visual survey of the subject building was conducted to determine if any mould was present. MPL observed mould growth in select areas of the subject building.

Photo 4: View of suspect mould growth observed on drywall in Room 100D.

Mould and Water stained/damaged drywall must be removed following Level I mould remediation procedures, as per EACC Guidelines.

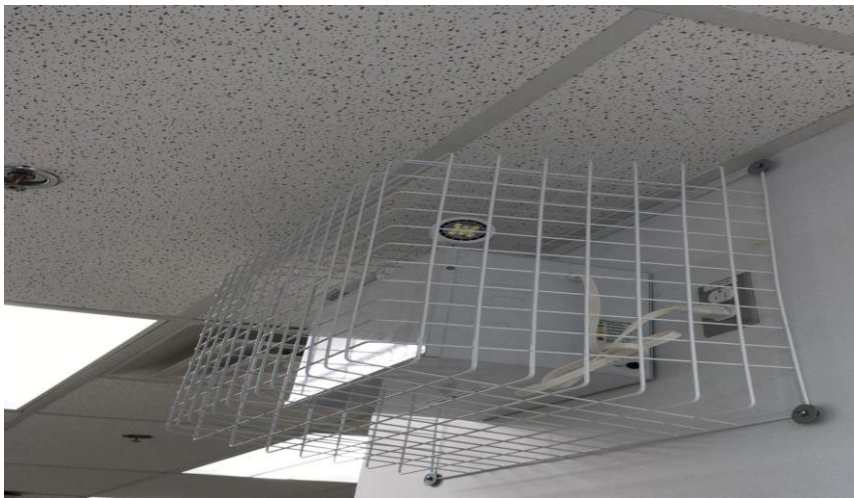
MPL identified lead-containing acid battery packs throughout the subject building. These battery packs were observed on walls and above exits throughout the surveyed building.

Photo 5: Typical view of emergency lights

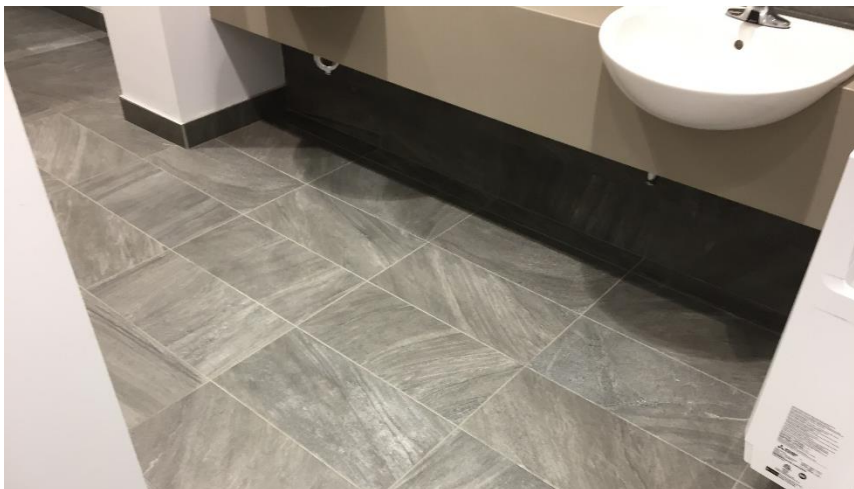
To avoid damage and compromising the integrity of the structure, no bulk samples of the ceramic wall/floor tile grout were collected. Prior to renovation/demolition, ceramic wall/floor tile grout should be examined and tested for asbestos content. Ceramic wall/floor tile grout should therefore be considered to contain asbestos until bulk samples and analysis proves otherwise.

Photo 6: Typical view of ceramic floor tile grout observed throughout the subject building suspected of containing asbestos.

- Materials identified to contain asbestos that are in good condition and do not pose a risk to workers or occupants can be managed in place. Prior to renovation/demolition activities that may disturb the ACMs, these materials must be removed following appropriate Type 1/2/3 asbestos abatement work procedures as detailed in O. Reg. 278/05 and disposed of as asbestos waste under O. Reg. 347;
