HAZARDOUS MATERIALS SURVEY AND 2023 REASSESSMENT ADVANCED RESEARCH COMPLEX (ARC), OTTAWA, ON

Project No.: Z2021101HZ / CCC-230252-00

University of Ottawa

November 28, 2023

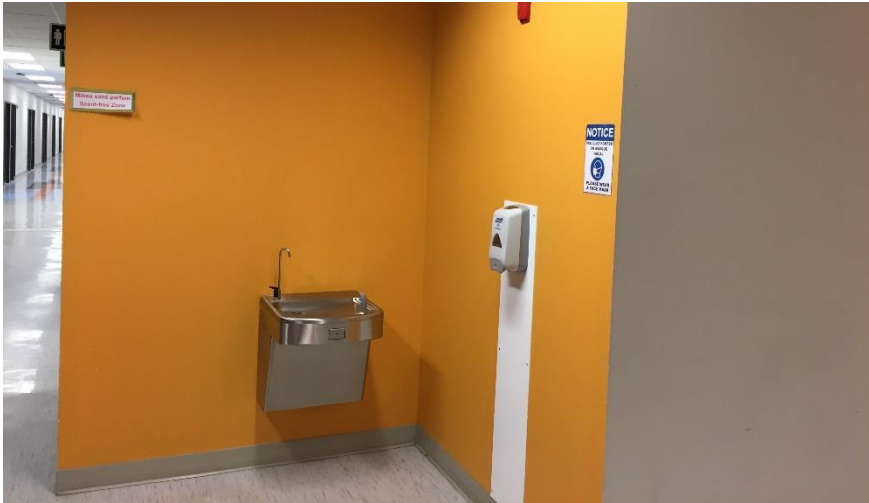
A visual assessment was conducted for equipment potentially containing ODSs and other halocarbons. MPL observed equipment such as refrigerators, water fountains, water coolers, freezers, etc., which contain or are suspected of containing ODSs or other halocarbons.

Photo 4: Typical view of ODS containing water fountain

Please refer to Appendix F – Hazardous Materials Checklist for equipment conditions, quantities (where applicable), and recommended actions.

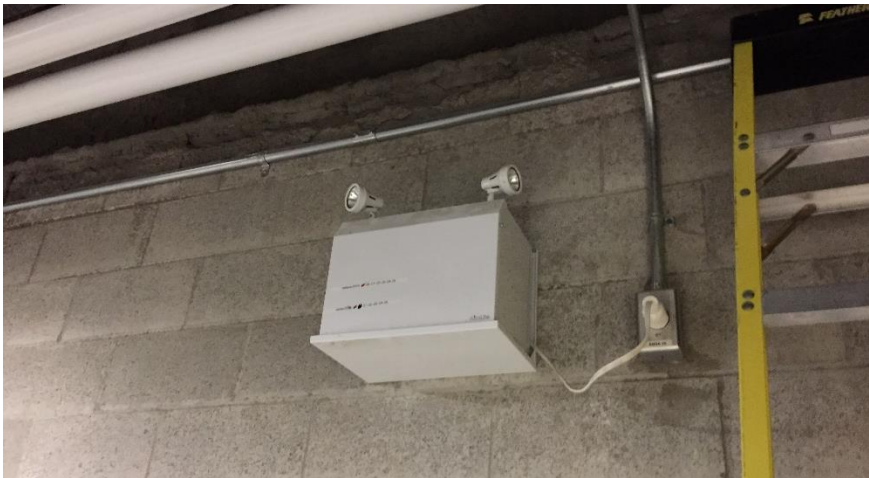
Lead-containing acid battery packs were observed in Room 532C.

Photo 5: View of the lead-acid batteries present in Room 532C.

Photo 6: View of the lead-acid batteries present in Room 532C.

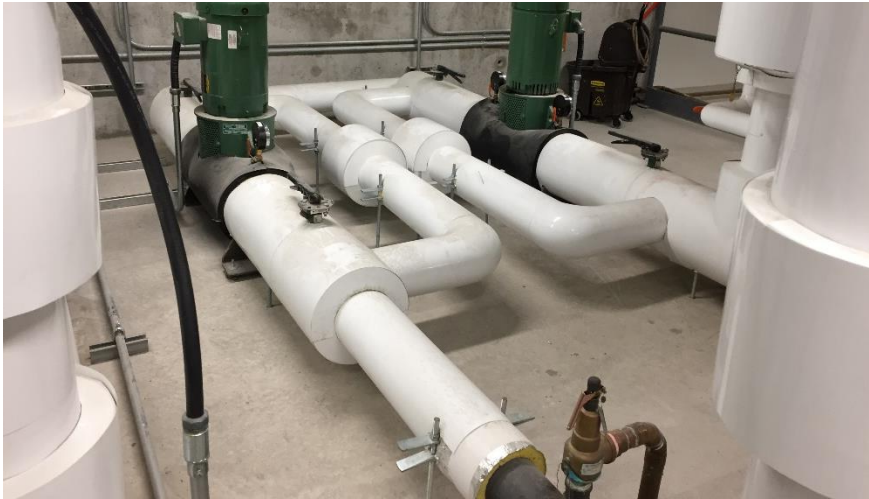
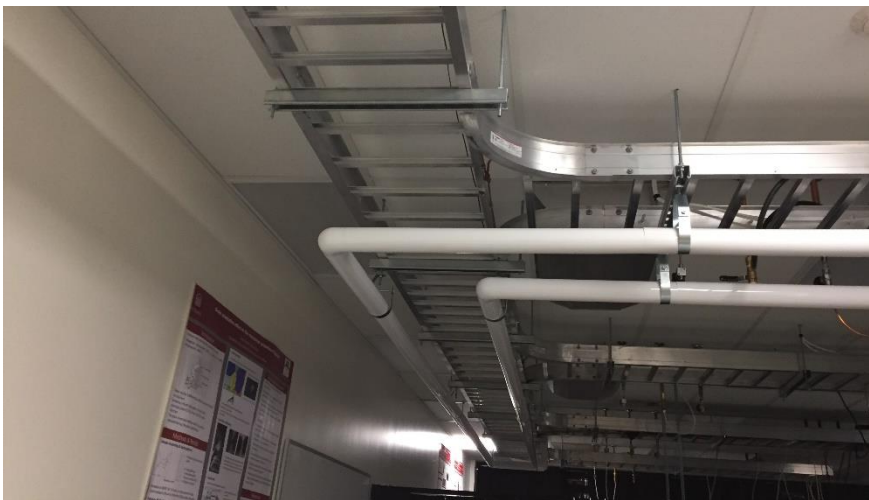
Mechanical pipe straight insulation was observed throughout the subject building. MPL made several incisions throughout to investigate its composition, and it was visually identified as fibreglass and, therefore, not suspected of containing asbestos.

Mechanical pipe elbows/fittings insulation was observed throughout the subject building. MPL made several incisions throughout to investigate its composition, and it was visually identified as fibreglass and, therefore, not suspected of containing asbestos.

Mechanical pipe hanger insulation was observed throughout the subject building. MPL made several incisions throughout to investigate its composition, and it was visually identified as fibreglass and, therefore, not suspected of containing asbestos.

Photo 7: A typical view of fiberglass mechanical insulation was observed throughout the subject building.

Photo 8: A typical view of fiberglass mechanical insulation was observed throughout the subject building.
