HAZARDOUS MATERIALS SURVEY AND 2023 REASSESSMENT 157 SERAPHIN-MARION PRIVATE, OTTAWA, ON

Project No.:0Z2021101HZ / CCC-230252-00

University of Ottawa

McIntosh Perry Limited (MPL)

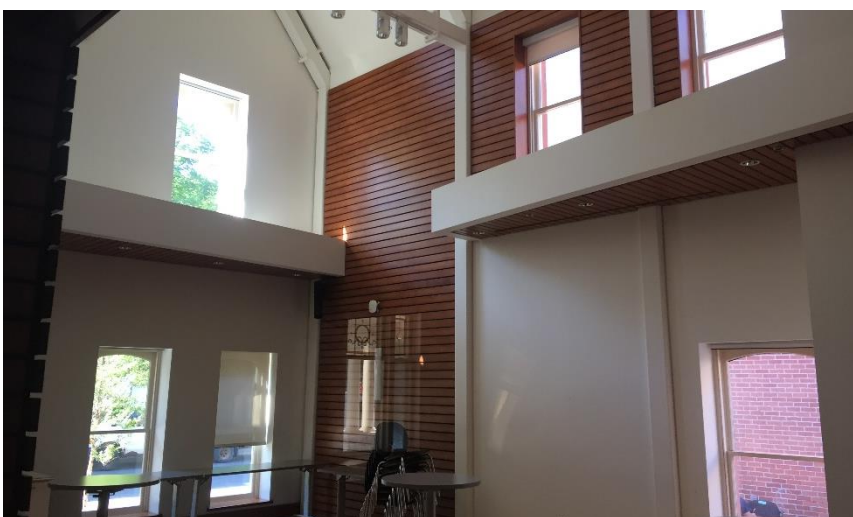
Photo 3: View of the interior finishes observed throughout the subject building.

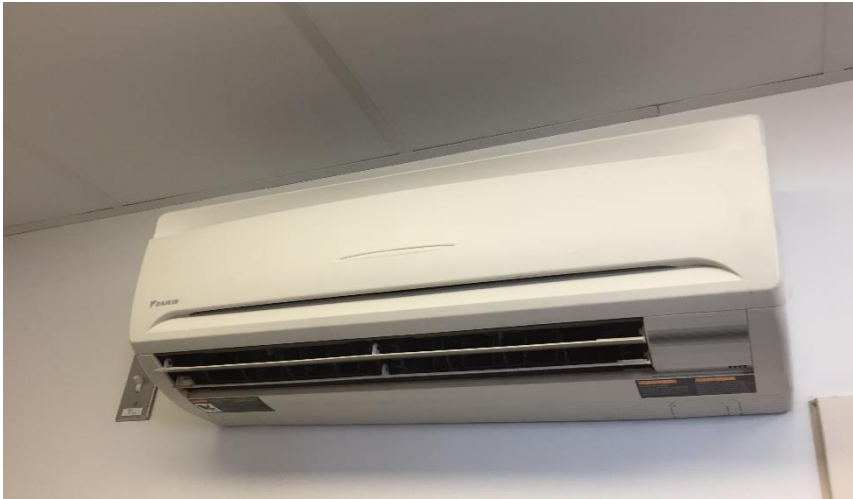
A visual assessment for equipment potentially containing ODSs and other halocarbons was conducted. Equipment containing ODSs or other halocarbons was observed in the subject building.

Photo 4: View of the equipment containing ODSs observed throughout the subject building.

Please refer to Appendix F – Hazardous Materials Checklist for equipment conditions, approximate quantities (where applicable), and recommended actions.

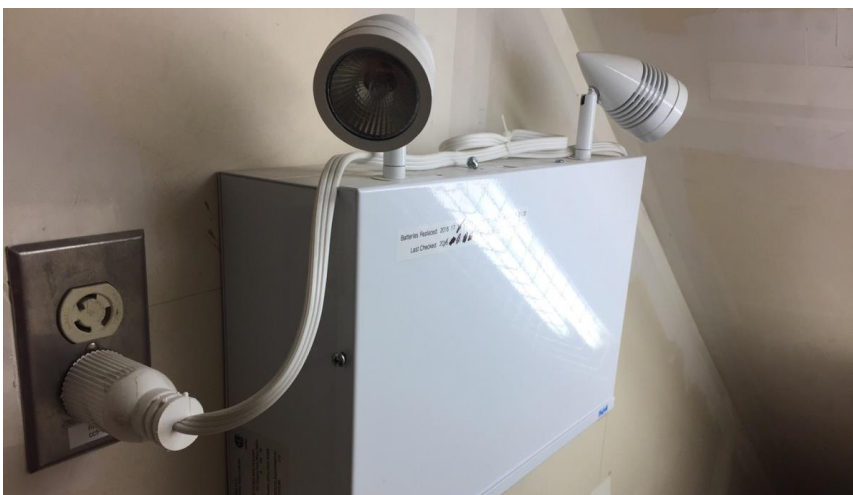
MPL identified lead-containing acid battery packs manufactured by Emergi-Lite throughout the subject building. These battery packs were observed on walls and above exits.

Photo 6: View of the lead-containing battery pack identified in Room 100C.
