# HAZARDOUS MATERIALS SURVEY AND 2023 REASSESSMENT ANNEX RESIDENCE, 265 LAURIER AVENUE EAST, OTTAWA, ON

Project No.: CCC-214260-00 / CCC-230252-00

December 06, 2023

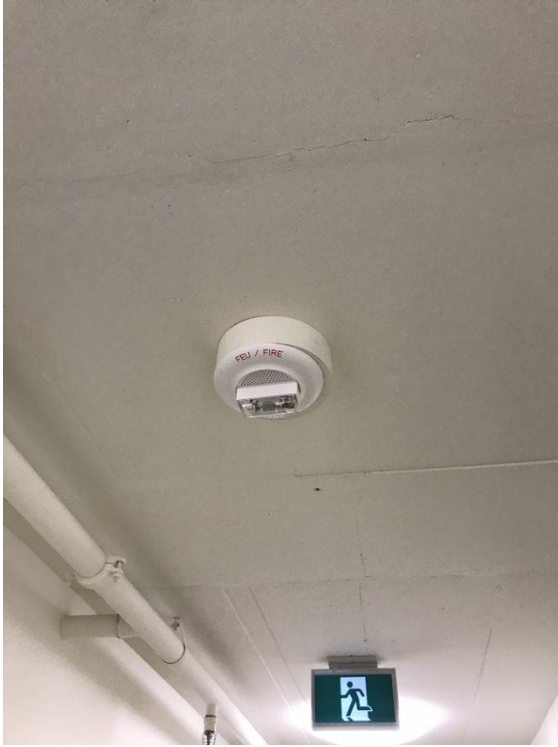
A visual assessment of the subject building was conducted to determine if any electrical components containing radioactive materials were present. MPL observed smoke detectors, which contains small quantities of radioactive material.

Photo 1: Representative view of the smoke detectors containing small amounts of isotope Americium 241, observed throughout the subject building.

The radioactive sources in smoke alarms are sealed and contained within a metal case inside the smoke detector and must not be damaged or tampered with. These materials do not pose a hazard as long as they remain contained and properly disposed at the time of removal or replacement.
