HAZARDOUS MATERIALS SURVEY AND 2023 REASSESSMENT MINTO SPORTS COMPLEX, OTTAWA, ON

Project No.: Z2021101HZ / CCC-230252-00

University of Ottawa

McIntosh Perry Limited (MPL)

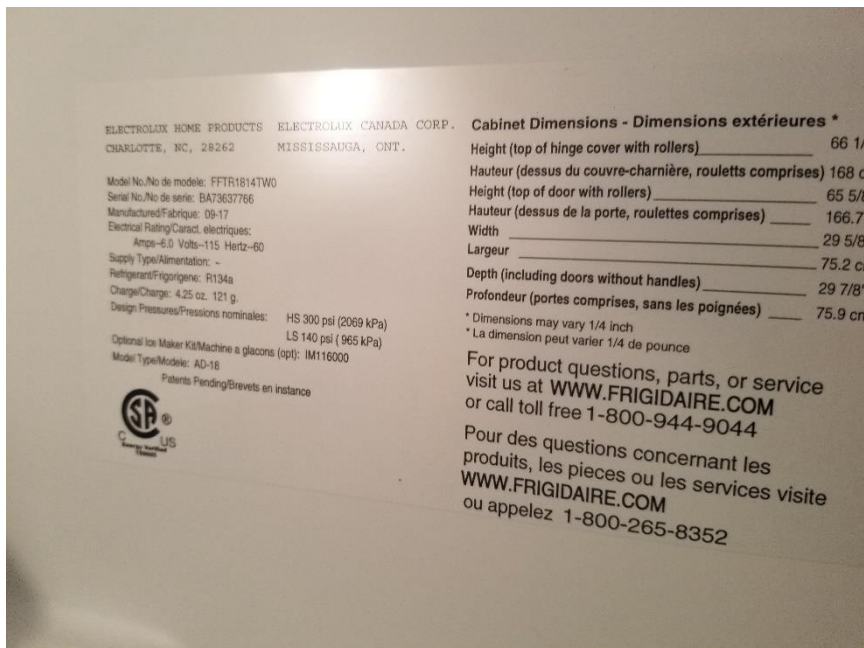
A visual assessment for equipment potentially containing ODSs and other halocarbons was conducted. Equipment containing ODSs or other halocarbons was observed throughout the subject building.

Photo 3: Typical refrigerators were observed to contain ODS.

Please refer to Appendix F – Hazardous Materials Checklist for equipment conditions, approximate quantities (where applicable), and recommended actions.
